The NEAR Rendezvous Burn Anomaly of December 1998

Final Report of the NEAR (Near Earth Asteroid Rendezvous)
Anomaly Review Board

November 1999

NEAR Anomaly Review Board

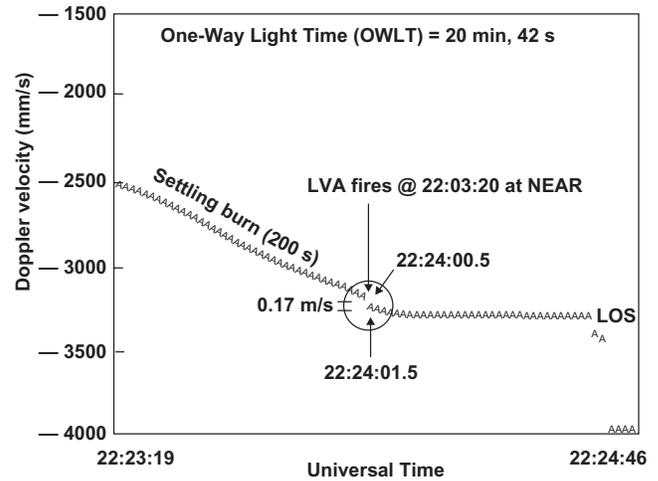
The sequence of small settling burns executed nominally beginning at $T - 200$ s on 20 December ($T = 0$ is the start time of the LVA burn). This sequence added about 6 m/s to spacecraft velocity, as planned. However, when the LVA burn began at $T = 0$, it shut down within a fraction of a second. RF communications from the spacecraft were lost at $T + 37$ s and not regained for 27 hours. The record of downlink Doppler measurements from the spacecraft (Fig. 1) shows these events up to loss of signal.

Figure 1. Spacecraft radial velocity, as measured by the downlink signal Doppler shift, shows the settling burn, the moment of LVA burn abort, and the subsequent loss of signal 37 s later. (Figure adapted from Ref. 4.)

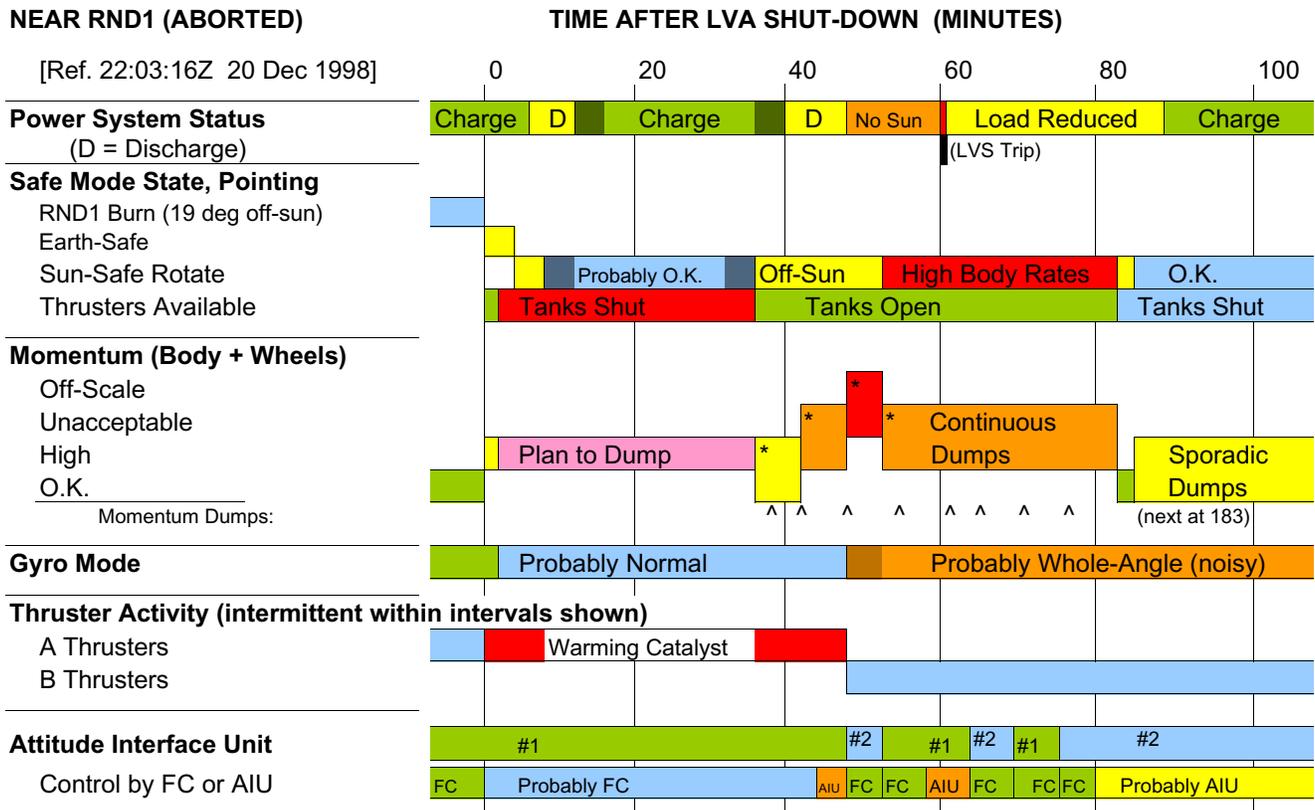
Figure 2. Early events in the RND1 timeline, measured from time of abort. Uncertainties in the timeline result from having to deduce and infer events from the small amounts of stored data remaining after the solid-state recorder was powered off during LVS.

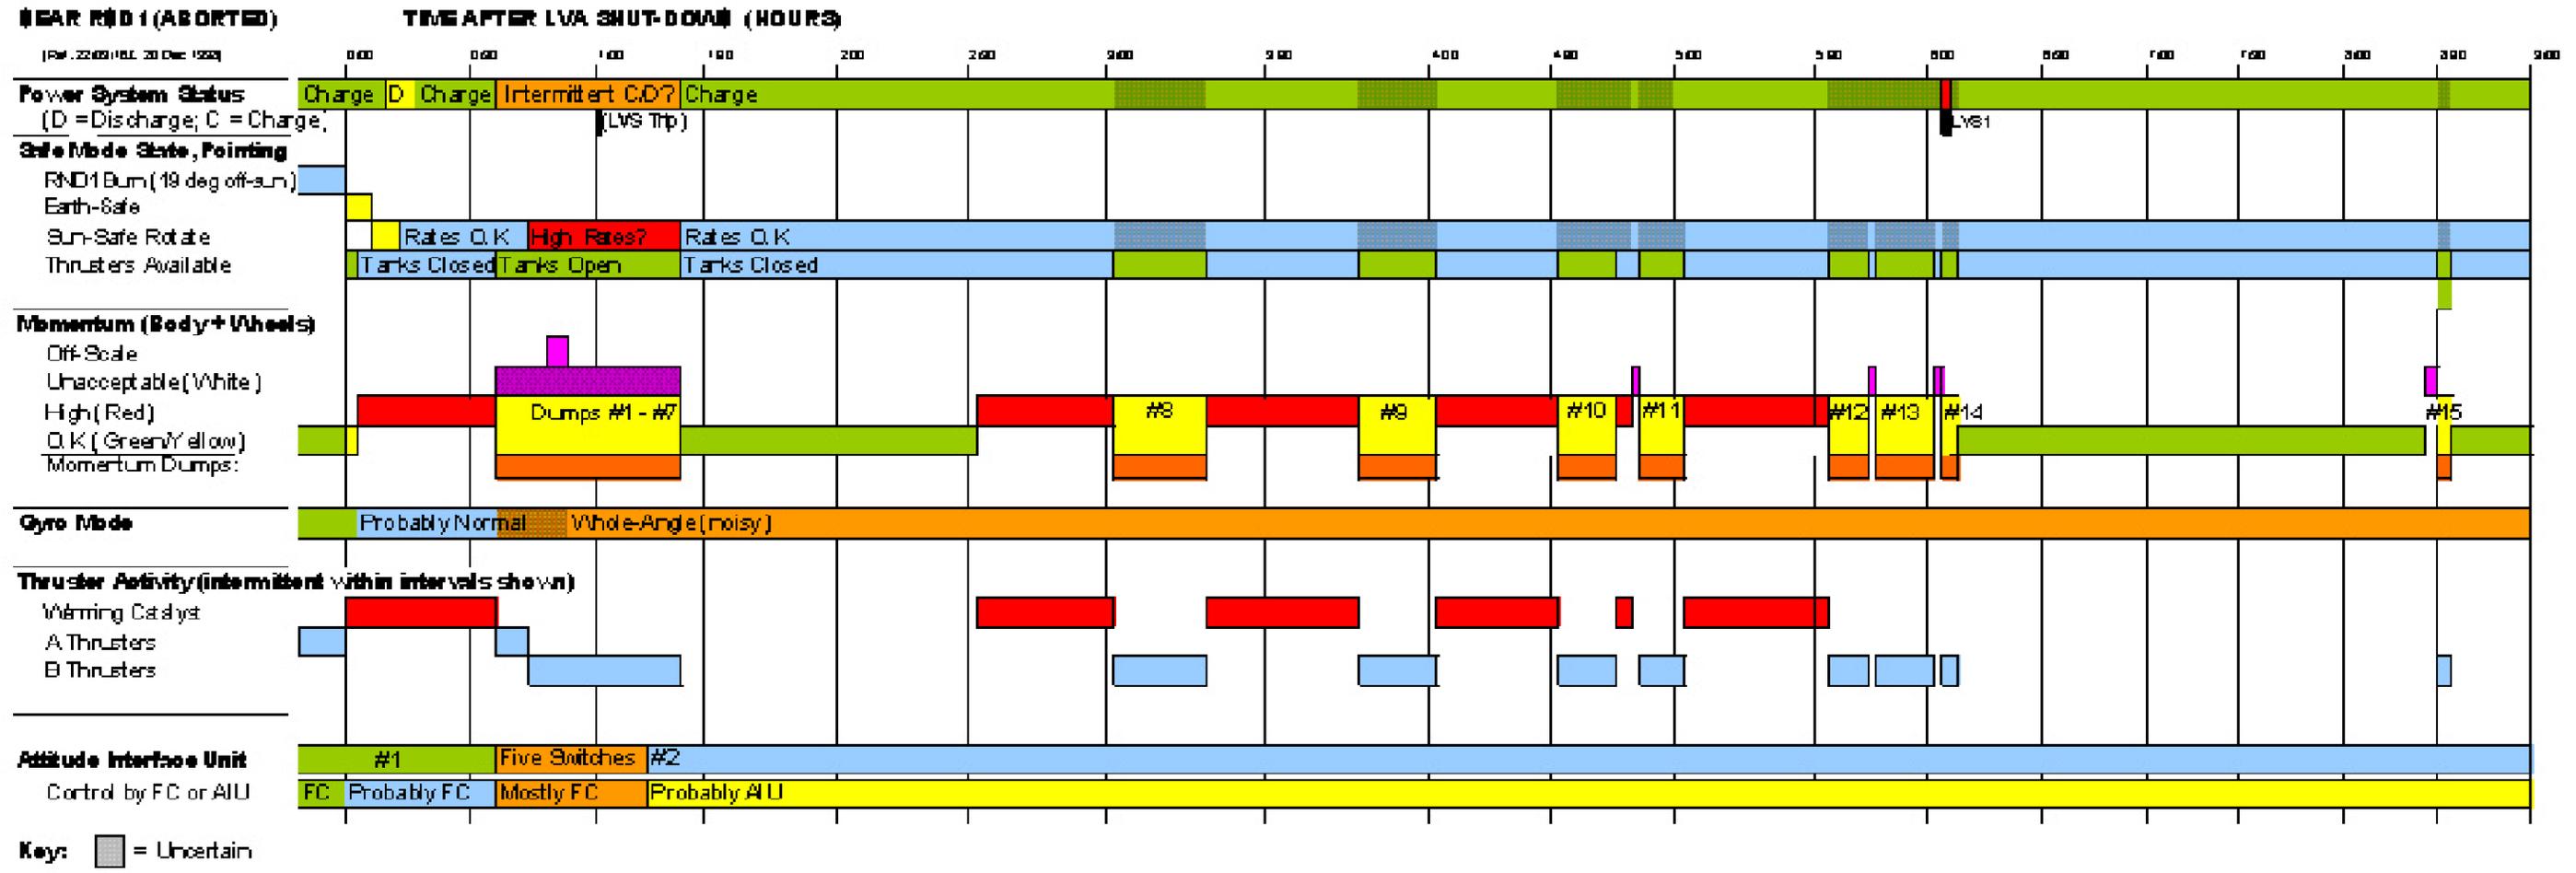
Figure 3. The complete RND1 timeline, derived from Table H-1 in Appendix H. Uncertainties in the timeline result from having to deduce and infer events from small amounts of stored data remaining after the solid-state recorder was powered off during LVS.

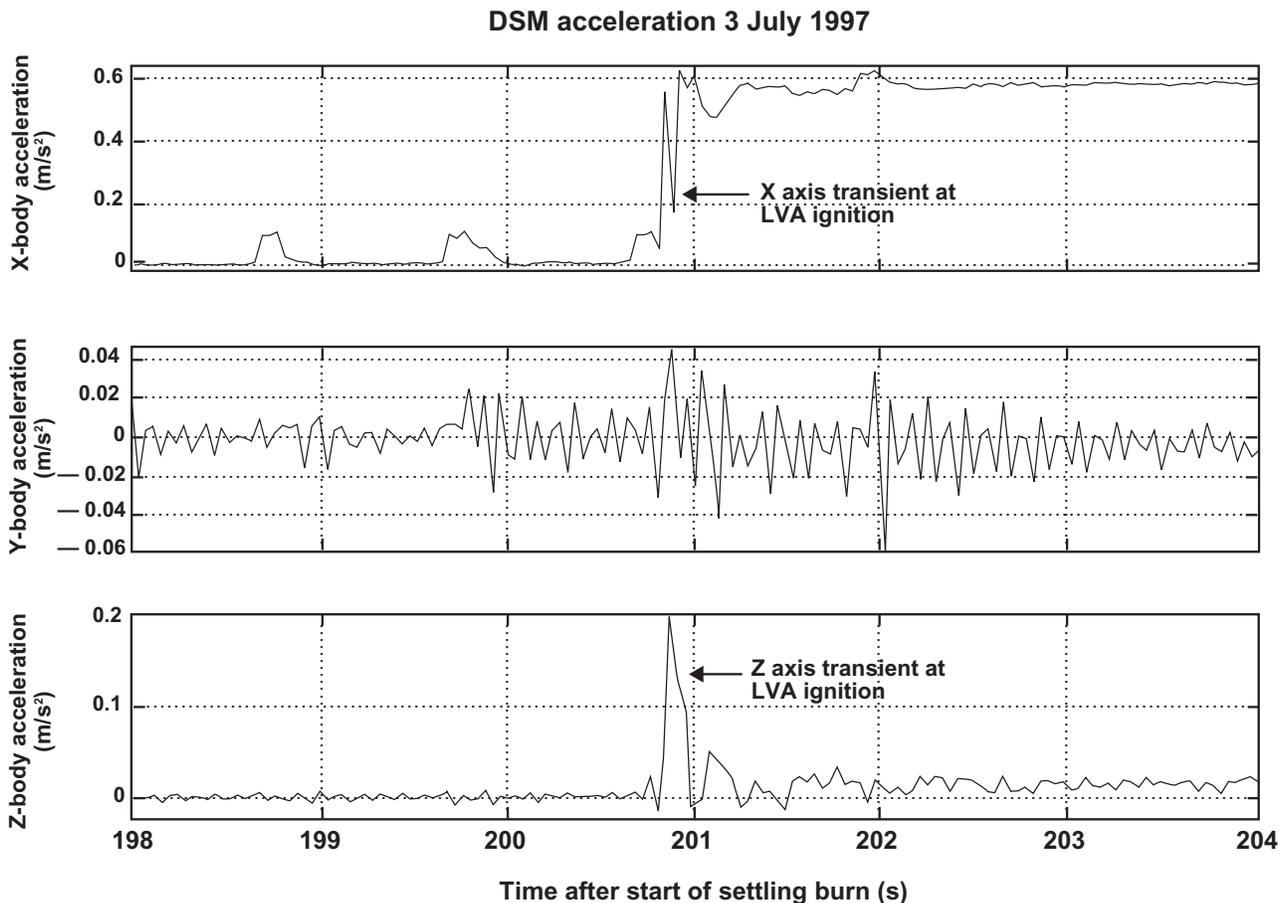
The series of anomalous events began at LVA ignition, when the accelerometers sensed a lateral acceleration probably in excess of 0.15 m/s^2 , which exceeded the threshold of 0.10 m/s^2 that had been set to detect uncontrolled lateral thrust during any burn. (Groups of four consecutive 100 sample/s accelerometer readings are averaged, then compared to a threshold.) This acceleration represented a reasonable mechanical response to the normally abrupt LVA start-up, and it can be concluded that the threshold was set too tightly. An LVA start-up transient had been observed on the only previous use of the LVA, the DSM burn of July 1997 (Fig. 4); however, the significance of this transient was not appreciated. In addition, NEAR's structural design, with a separate propulsion module cantilevered from the base of the spacecraft, heightens the mechanical coupling of this transient to the accelerometers (Fig. 5 and Appendix G); this bending response was not appreciated. In

retrospect, the correct thing for the G&C software to have done would have been to ignore (blank out) the accelerometer readings during the brief transient period, or at the very least to increase the filtering and/or raise the threshold during that time. It is significant that NEAR is the first of JHU/APL's 58 spacecraft to use bipropellant propulsion, and RND1 was only the second time the LVA was fired in orbit.

Figure 4. An acceleration transient similar to that which initiated RND1 occurred during the only previous use of the LVA engine, the Deep Space Maneuver burn in July 1997. The significance of the transient was not appreciated at the time.

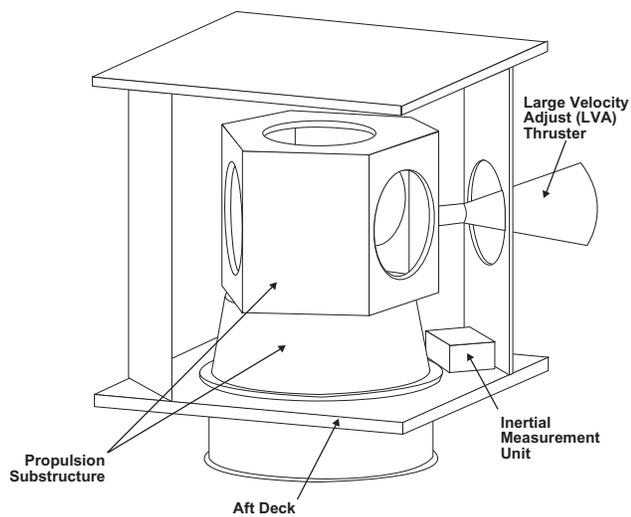
Figure 5. NEAR's structural design uses a separate propulsion module cantilevered from the aft deck of the main spacecraft structure. The resulting flexure during LVA ignition couples into the accelerometers located in the Inertial Measurement Unit. (Propulsion tanks and two side panels are removed for clarity.)

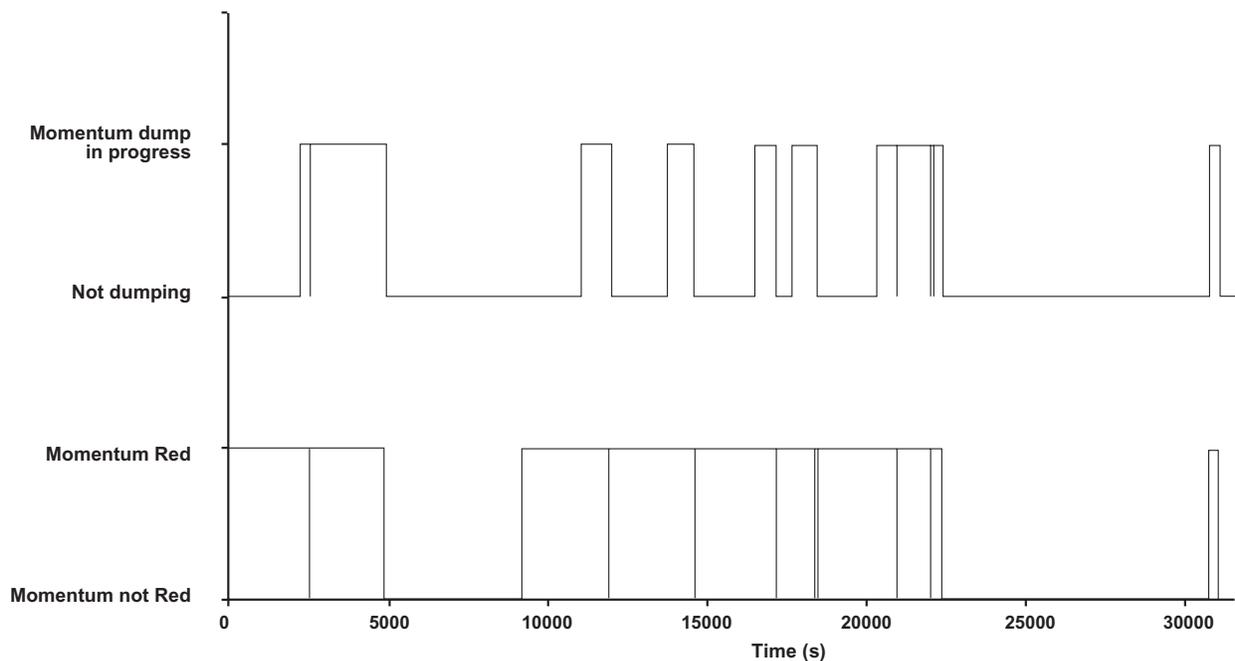
Figure 6. Extracted from Fig. 3 and Table H-1 in Appendix H, this figure illustrates that momentum dumps occurred in three distinct groupings, separated by quiescent periods up to 2 hours long. When momentum goes Red, a 30-min warm-up of the thruster catalyst bed heaters begins in anticipation of an autonomous momentum dump.

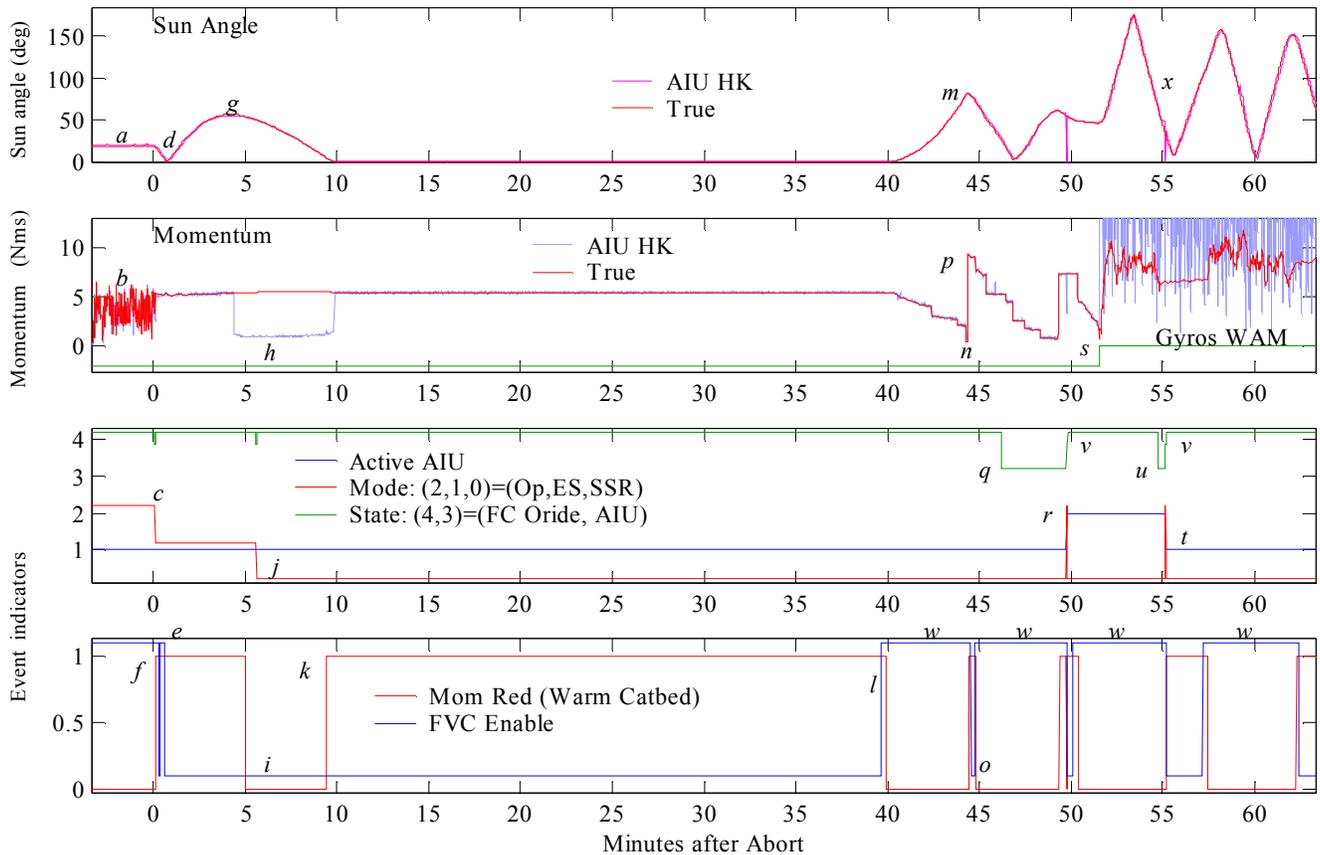
In simulation run 126 (shown in Figs. 7, 8, and 9), the event begins with the spacecraft pointed 19° from the Sun during the 200-s settling burn (point *a* of Fig. 7). The system momentum is highly variable due to the thruster firings (point *b*). At abort the spacecraft demotes from operational to Earth-safe mode (*c*). The G&C actuators selection was set to thrusters only for the LVA burn, and the thrusters now slew the spacecraft toward the Sun (*d*). Meanwhile, the command and telemetry processor (CTP) begins executing the burn-abort macro, which removes power from the thrusters (*e*). Without powered thrusters, the G&C system ignores

Figure 7. Simulation 126 illustrates the “classic” early timeline behavior. Shown are true and reported Sun angle and total momentum, as well as indicator flags showing which processor is in control and its state, as well as spacecraft mode. The bottom chart shows the momentum Red flag and the state of the thruster enable line.

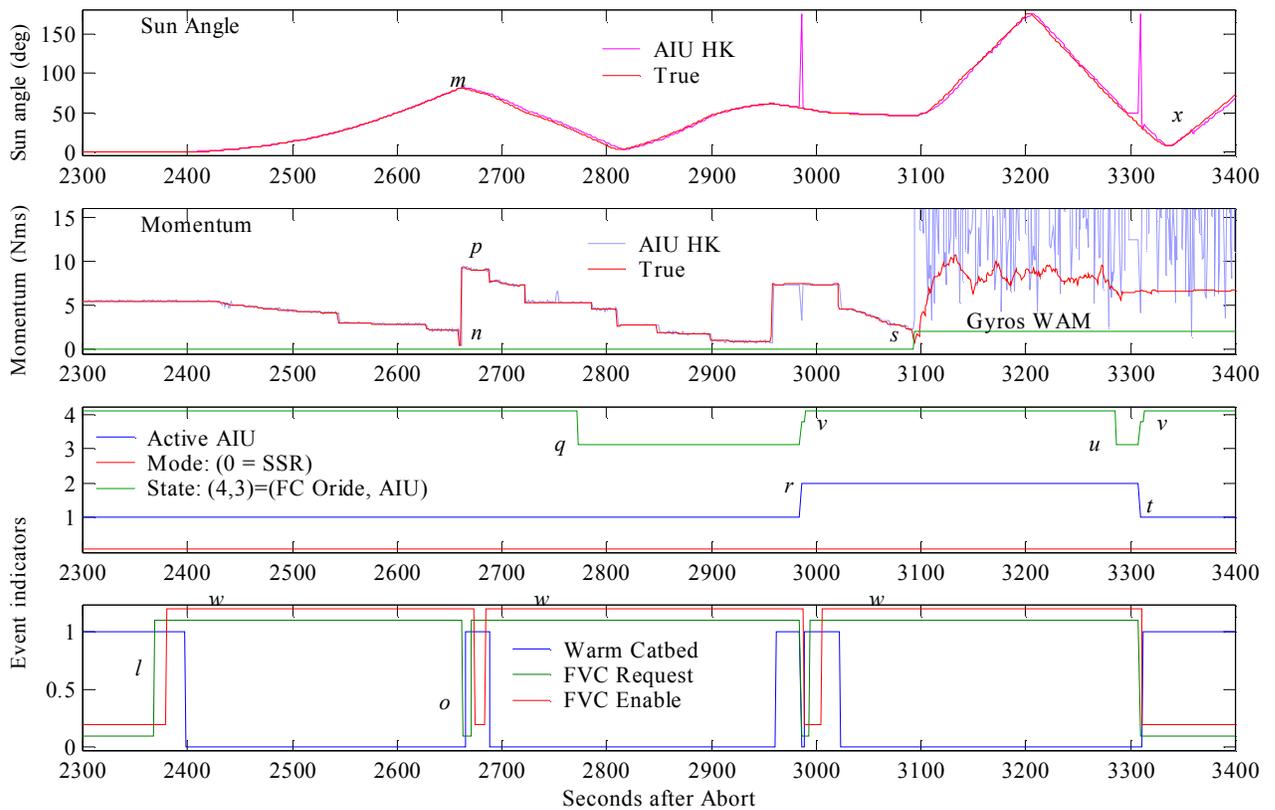
Figure 8. Expanded view of Fig. 7 at the time of the first momentum dumps. In this simulation, the gyro is manually forced into WAM at about 3100 s (with artificially high noise level).

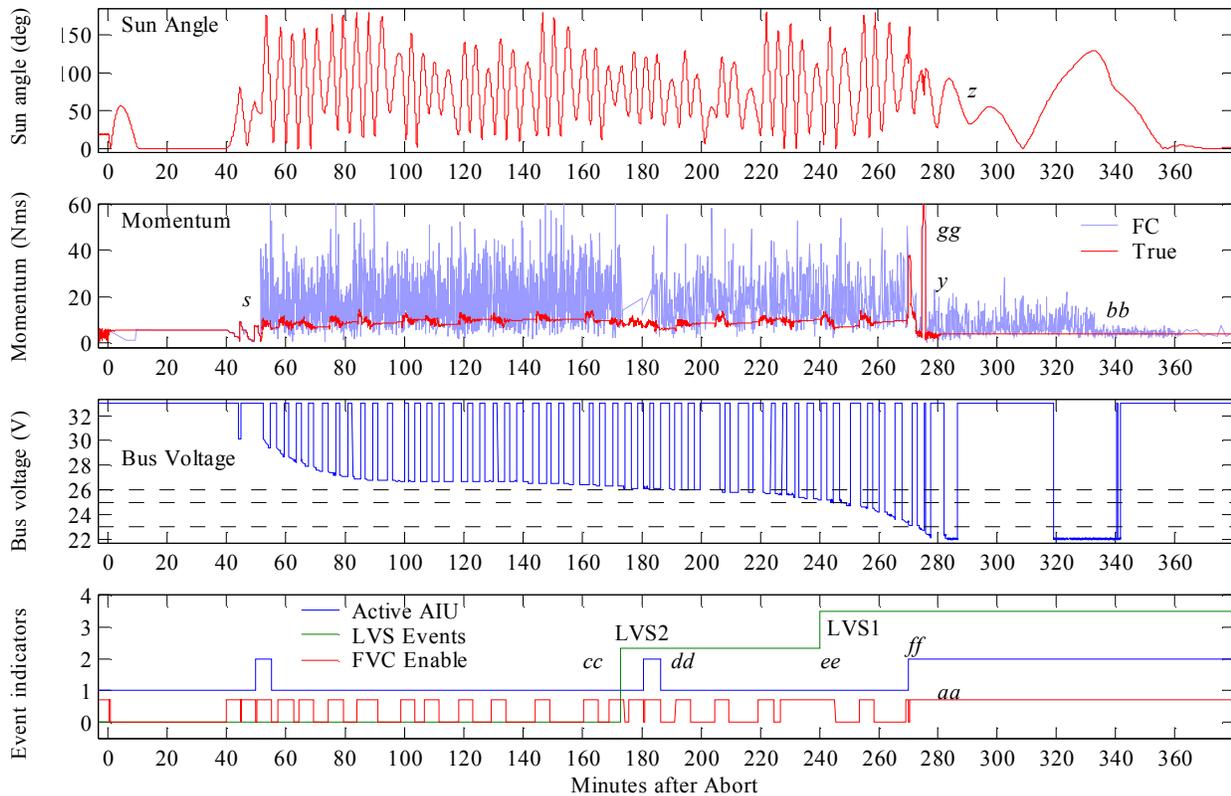
Figure 9. Illustration of the poorly controlled attitude and momentum when the gyros are in WAM. The third panel shows the power system status as simulated by a model within the brassboard (LVS trip point is 26 V). The bottom panel shows G&C processor and thruster status.

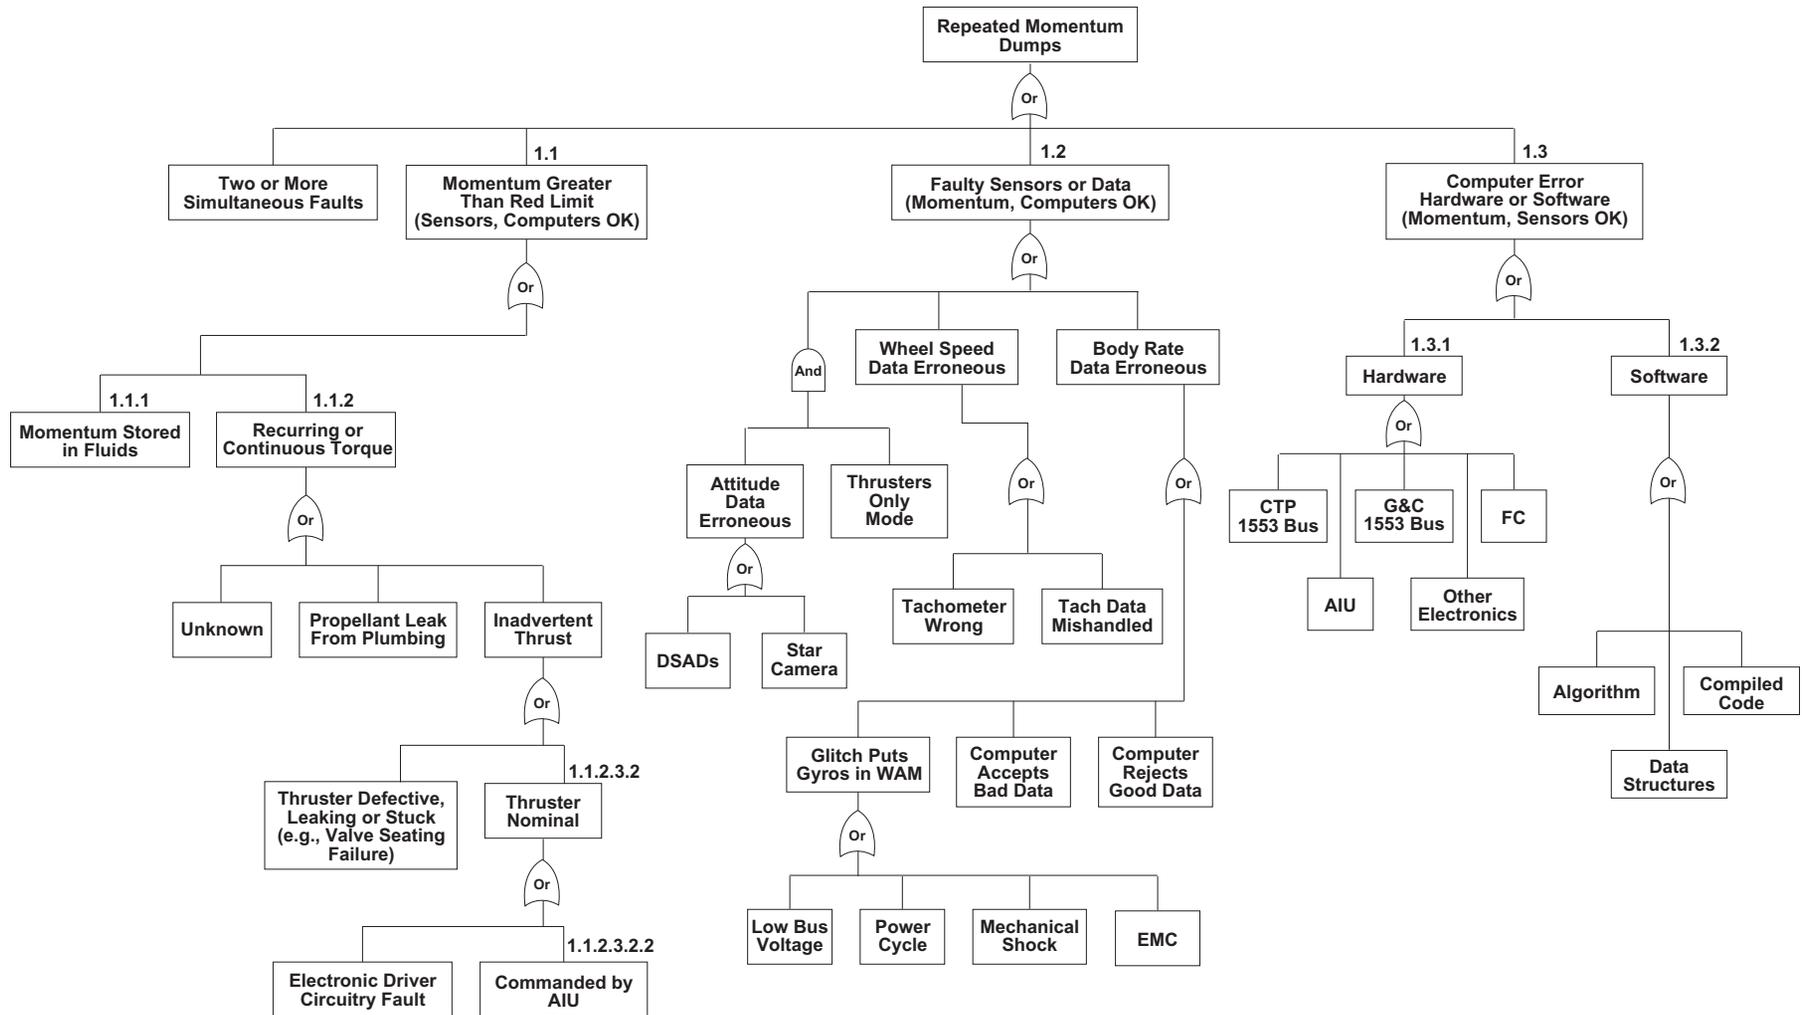
Figure 10. Fault tree of possible causes of the RND1 repeated momentum dumps. Certain events result from AND-ing or OR-ing other events. Numbered events are discussed more completely in the text.

In addition to a thruster valve seat leaking, software or drive electronics failures could erroneously command a thruster ON, which would have essentially the same effect as a leak. Branch 1.1.2.3.2 of the fault tree (Fig. 10) results in one or more FVC thrusters being falsely directed to open, imposing a momentum-raising torque on the spacecraft. The AIU circuitry that drives
