Rail Accident Investigation Branch

Rail Accident Report

Collision with buffer stops at King's Cross 17 September 2015

Report 15/2016
August 2016

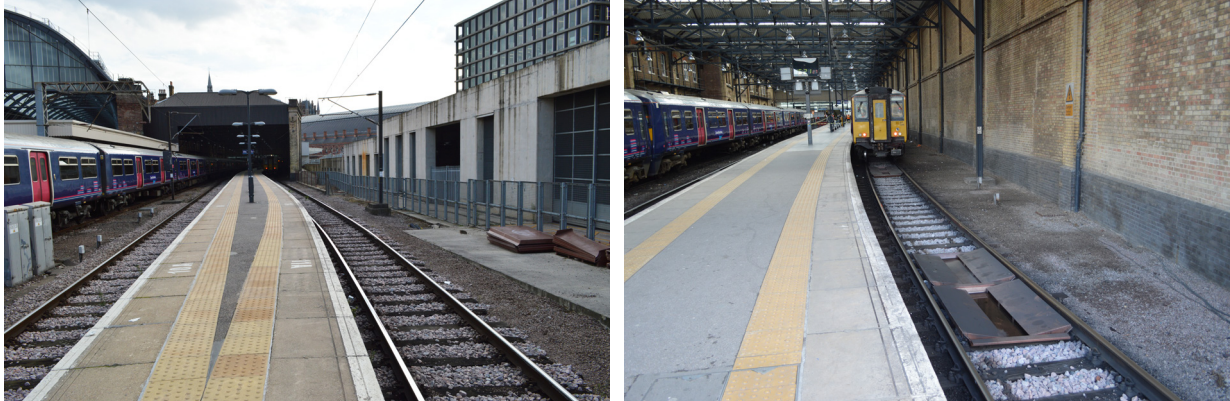
Figure 2: Platform 11 at King's Cross

- 6 Platform 11 is 170 metres long, and will accommodate an eight-car train. The maximum permitted speed for trains entering and leaving King's Cross station is 15 mph (24 km/h). Platform 11 is fitted with TPWS equipment which is designed to apply an arriving train's brakes if it is travelling at more than 10 mph (16 km/h) at a point 55 metres from the buffer stops.

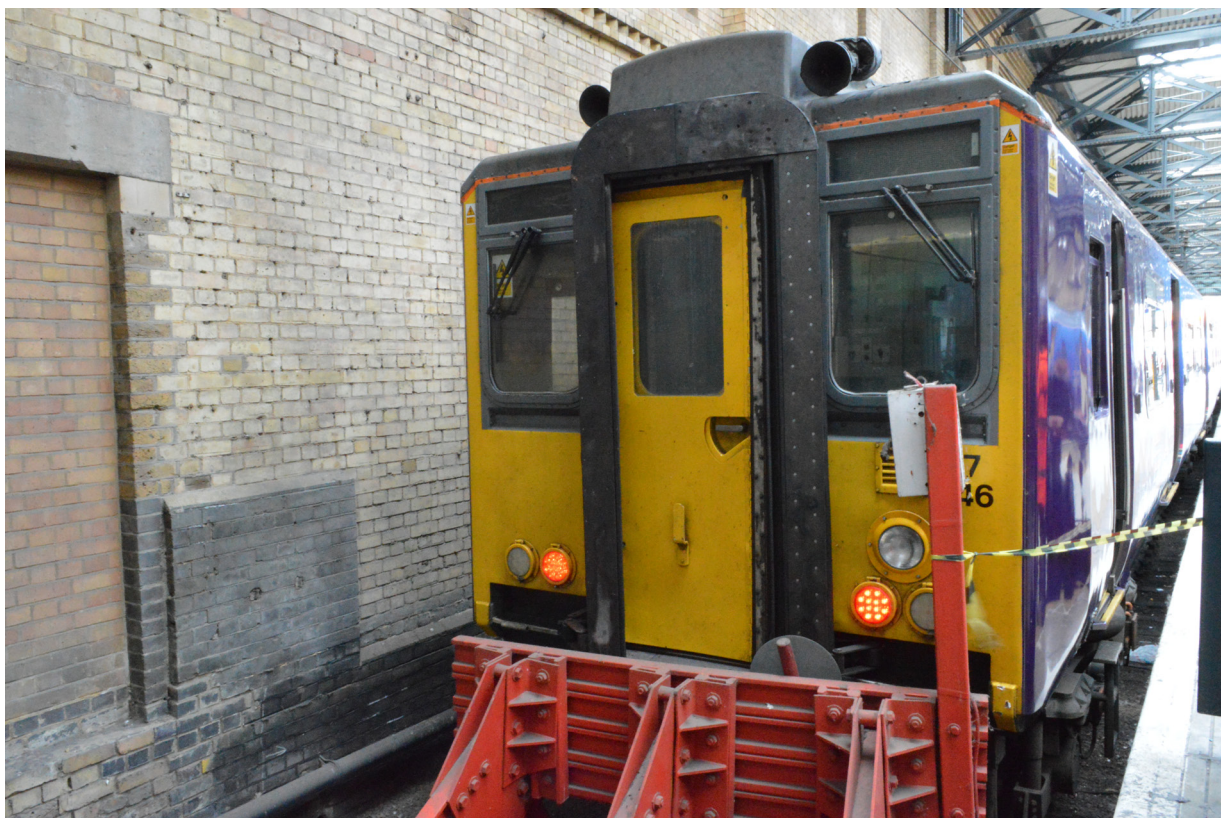
At around 12:18 hrs on Thursday 17 September 2015, the 10:55 hrs service from Cambridge collided with the buffer stops at platform 11 of King's Cross station, London. The train was formed of a four-car class 317 electric multiple unit and was being driven at the time by a trainee driver under the supervision of a driver instructor. The train came into the platform at normal speed, but the brakes were not applied so as to bring the train to a stand before the collision with the buffer stops occurred. At the time of the collision, the train was travelling at around 7.5 mph (12 km/h). Upon contact with the buffers, the train stopped rapidly, with the buffer stops moving back a short distance.

Fourteen passengers reported injuries: of those, four were treated by the London Ambulance Service and two were taken to hospital. Both were released later the same day. There was minor damage caused to the buffer stops and the outside of the train. A small number of interior fittings were dislodged during the impact and at least one passenger was struck by a detached lighting diffuser as it fell from the ceiling of the train.

Figure 3: The train and the buffer stops after the accident

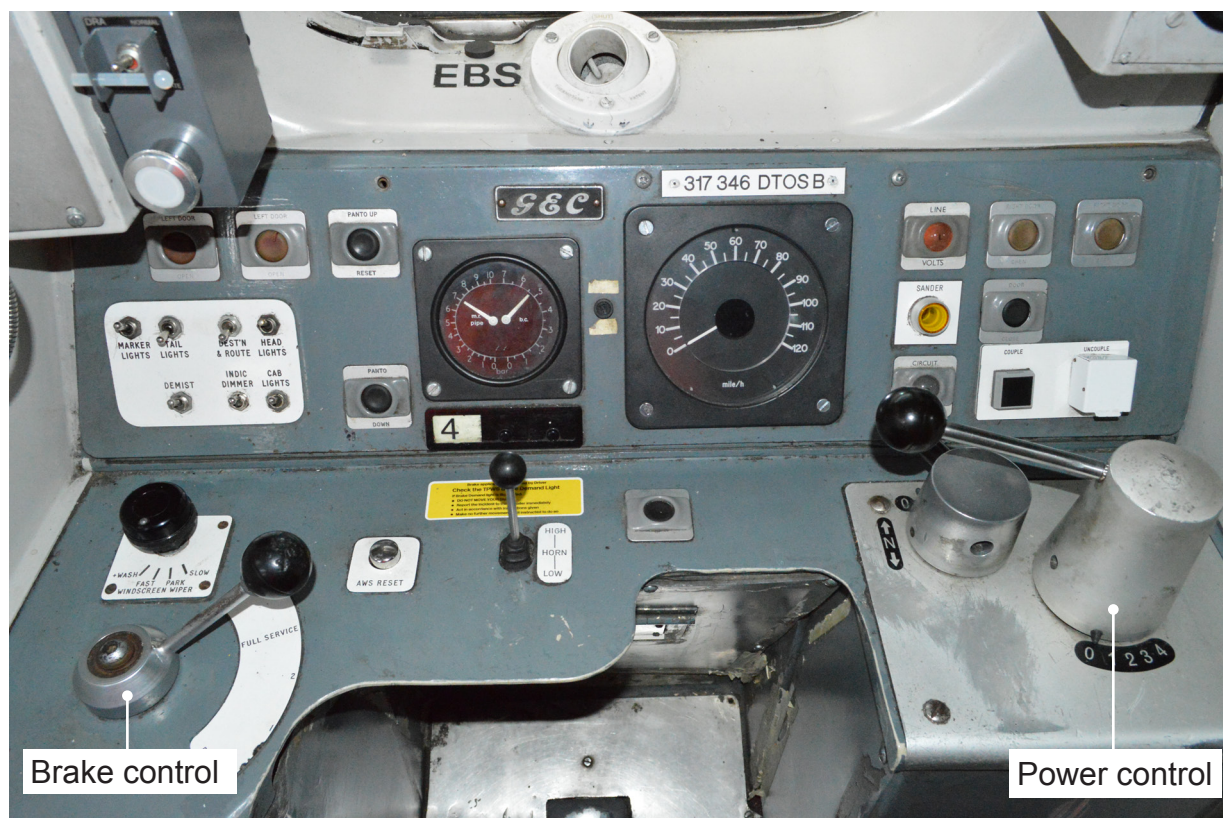
42 The OTDR evidence shows that the trainee driver applied power shortly before the train struck the buffers. The trainee driver's evidence is that he intended to apply the brake, but selected the power handle (on the right of the control desk) instead of the brake handle (on the left).

- 46 The trainee driver had driven class 313 trains, in sidings and empty on the main line, for about five hours, but 17 September 2015 was the first time he had driven a train in passenger service on the main line. His previous work had been driving mechanical handling machinery (fork lift trucks) in which the driver controls speed and braking using their feet, as with a road vehicle.
- 47 The class 317 is typical of electric trains of its era (1970s and 80s) in having separate controls for brake and power (figure 4). More modern passenger trains have the two functions combined into a single controller, usually placed to the left of the driver.

Figure 4: Layout of controls in class 317. The class 313 has a similar layout.

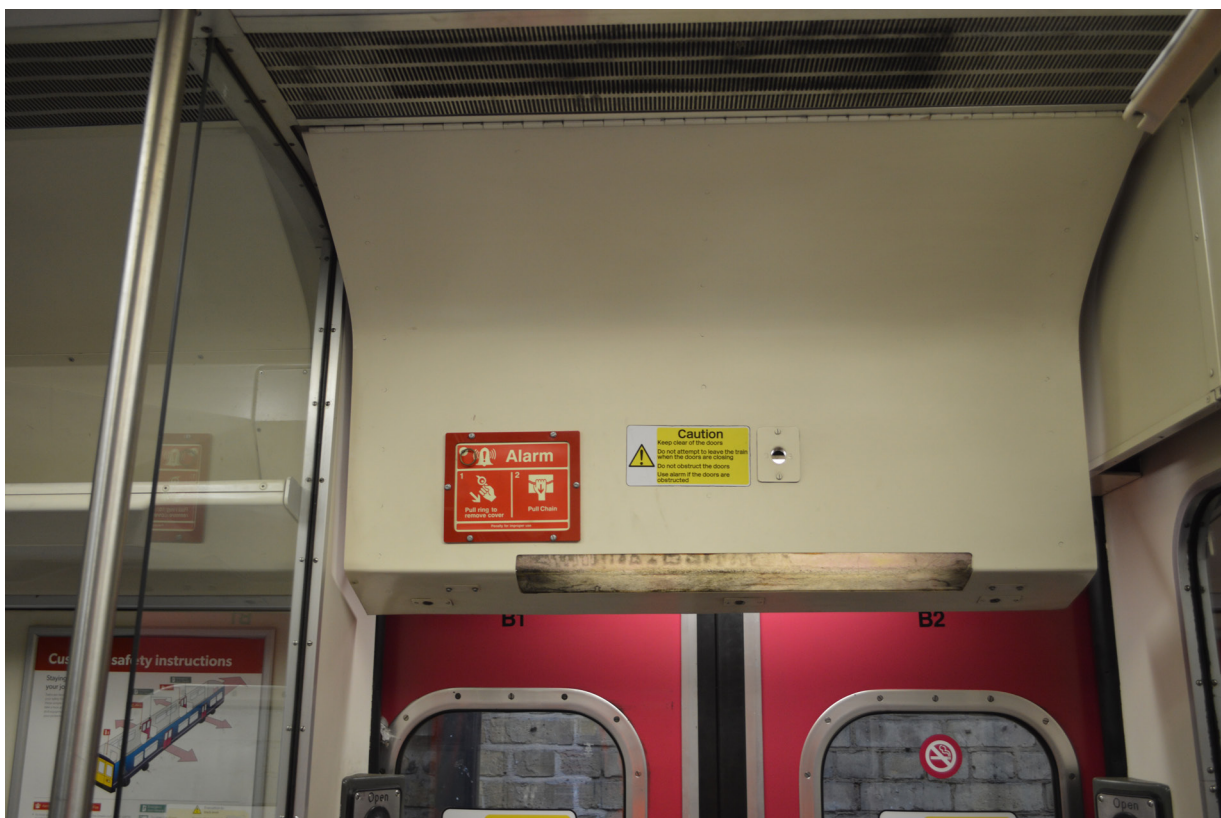
Figure 5: Door header panel, dropped following the accident but restrained by secondary straps (hidden)

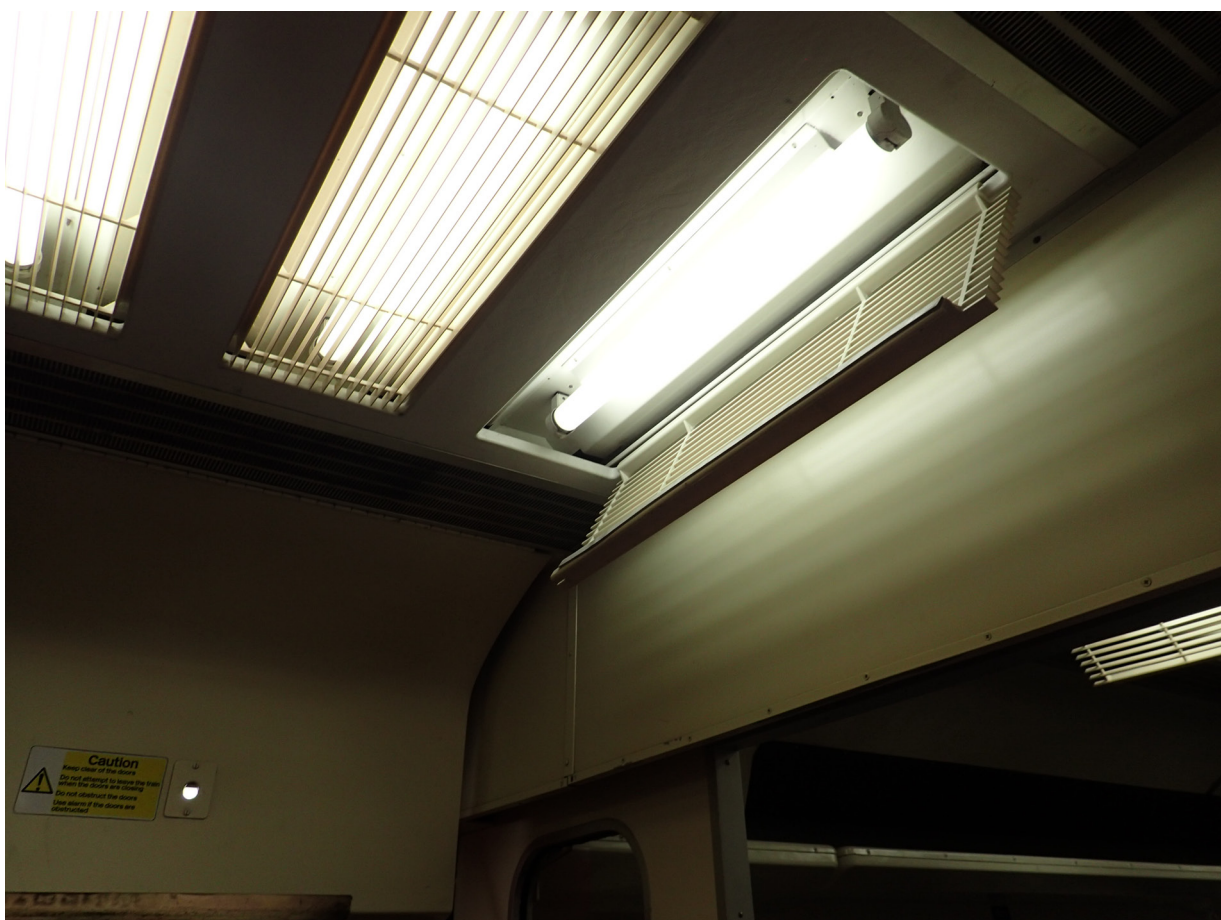
- 78 In the leading carriage, at least three lighting *diffuser grids* dropped from the row that runs along the centre of the ceiling (figure 6), and at least one of them struck a passenger (figure 7). These grids are made from lightweight plastic and are unlikely to cause serious injury. They rest in place in the apertures in the ceiling, and are not secured in place. As originally designed, the diffusers were prone to dropping out of the ceiling if the train lurched or stopped abruptly, or if passengers interfered with them, and a modification was made in 2012 to add a metal strip to one side that hooks over one edge of the aperture, and helps to retain the diffuser in position. Evidence from GTR is that this has reduced the problem, but this accident shows that the diffusers can still be dislodged by an impact.

Figure 6: Ceiling of first vehicle, showing displaced lighting diffusers

92 Fourteen passengers were injured in the collision, and some passengers were struck by items which fell from the vehicle ceiling. Action has previously been taken to minimise the risks from this cause (paragraph 78), and no further recommendation is made.

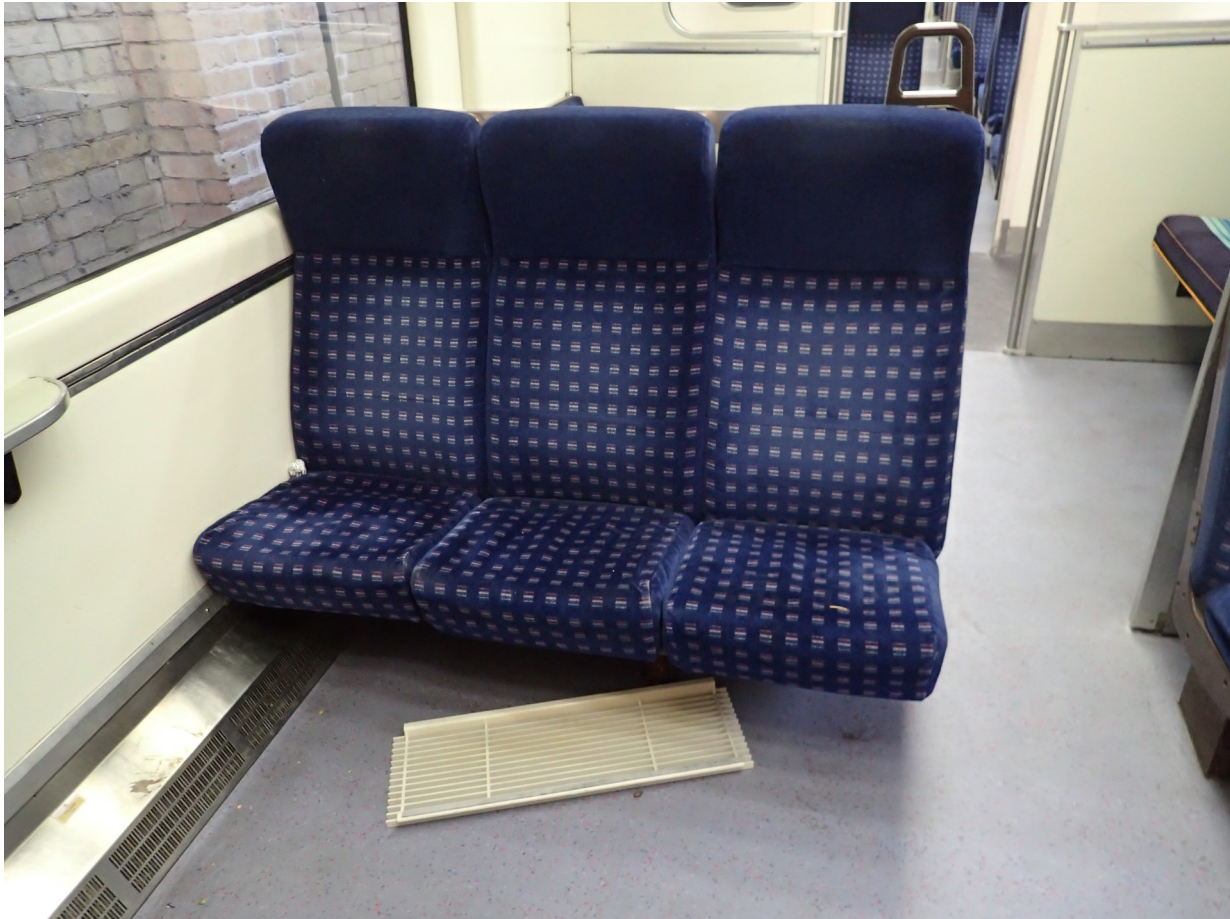
Figure 7: Diffuser on saloon floor following the accident
