AIRCRAFT INCIDENT REPORT

BOEING 747, N732PA

RENTON AIRPORT

DECEMBER 13, 1969

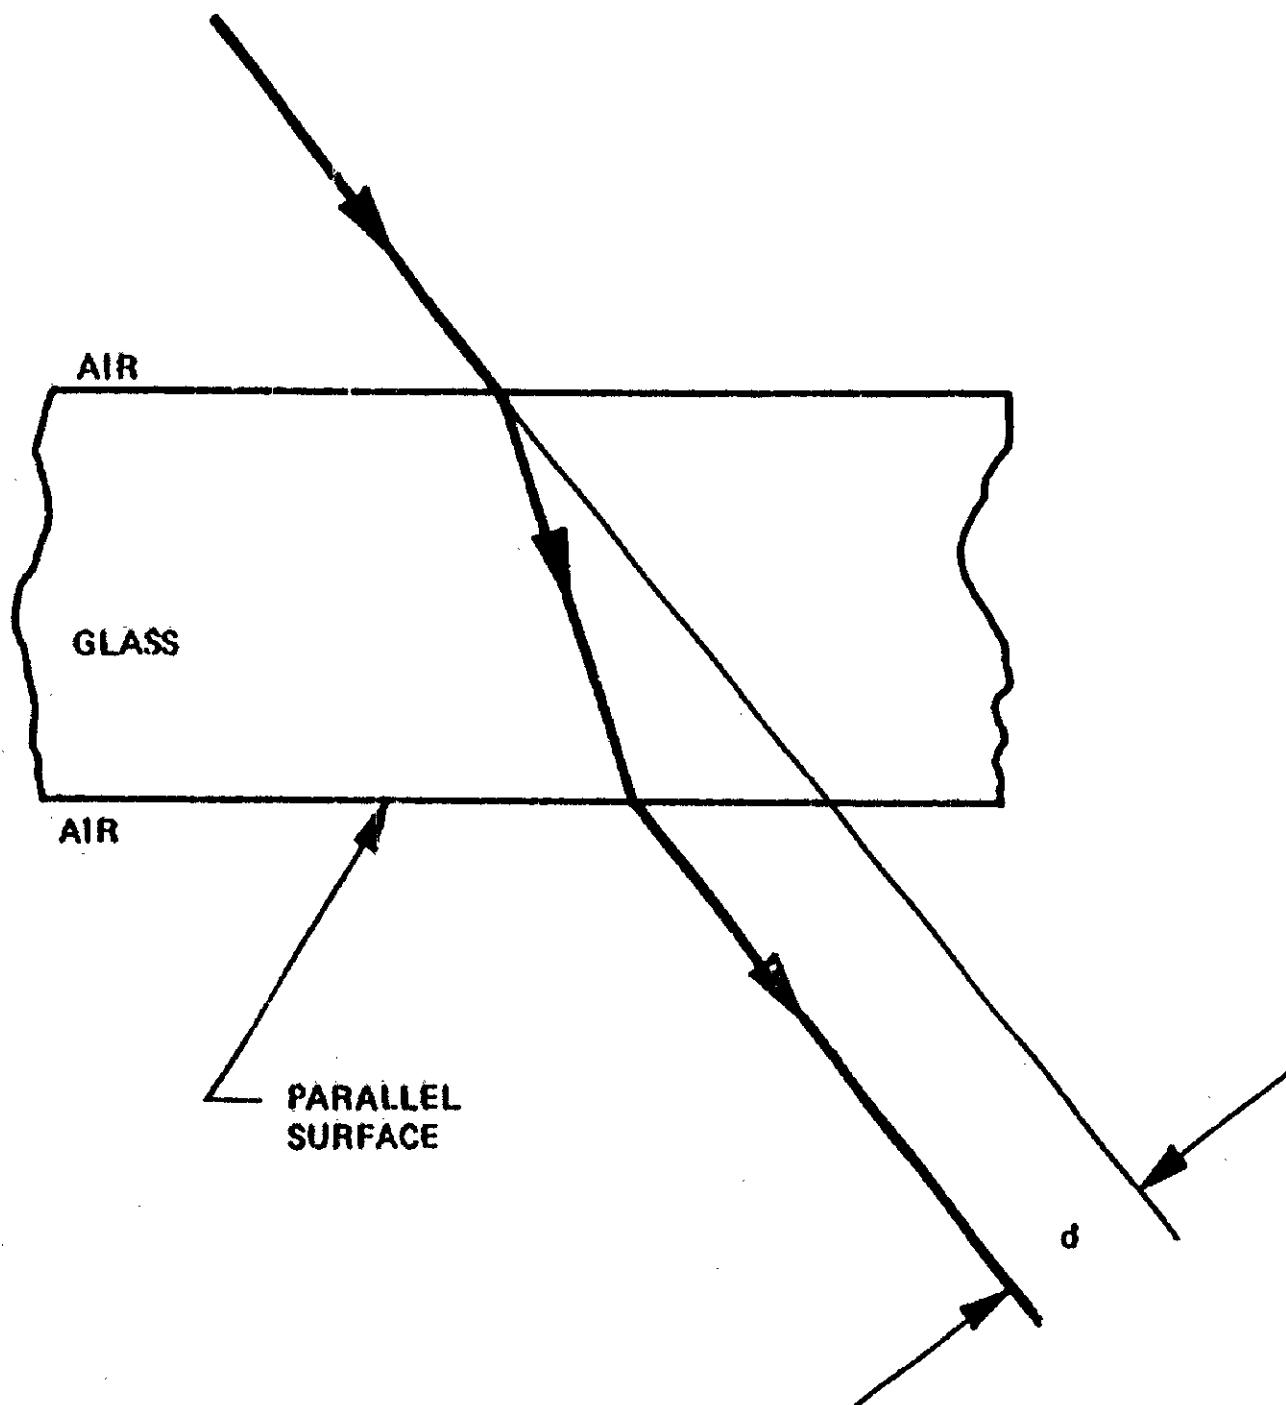
ATTACHMENT 4.

The Board considered the possibility that the curved windshield may have produced distortion or deviation sufficient to have caused the pilot to think that he was higher than he was. A Boeing study reveals that the total displacement is 9.6 feet in 1,000 feet, an amount which would be hardly discernible.

WHEN A LIGHT BEAM STRIKES AT AN ANGLE THE INTERFACE BETWEEN TWO MATERIALS HAVING DIFFERENT INDICES OF REFRACTION, THE LIGHT BEAM IS BENT.

WHEN THE LIGHT BEAM LEAVES A SURFACE PARALLEL TO THE FIRST, IT IS PARALLEL TO THE ENTERING BEAM. THE BEAM IS DISPLACED A DISTANCE "d" FROM ITS ORIGINAL PATH. DISPLACEMENT IS RELATIVELY SMALL.

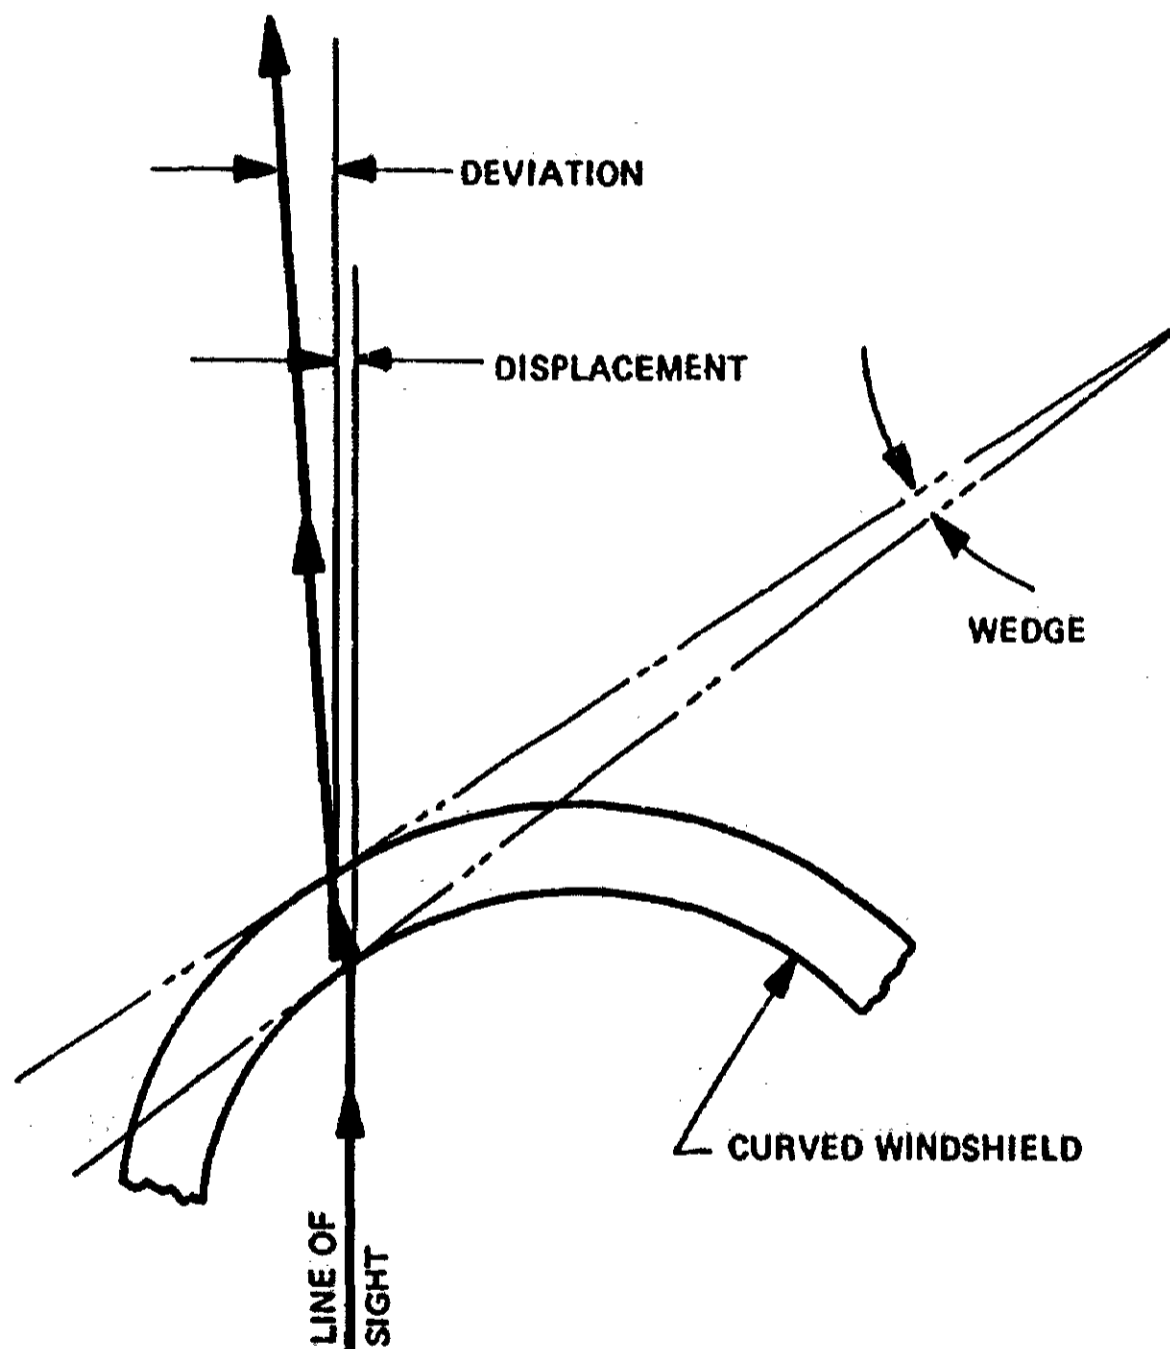
ATTACHMENT 5.

WHEN THE SURFACE THE LIGHT ENTERS IS NOT PARALLEL TO THE SURFACE FROM WHICH IT LEAVES, THE DIRECTION OF THE LIGHT IS CHANGED. THIS IS CALLED THE 'WEDGE EFFECT.'
