APOLLO PROGRAM SUMMARY REPORT

National Aeronautics and Space Administration
LYNDON B. JOHNSON SPACE CENTER

April 1975

JSC-09423

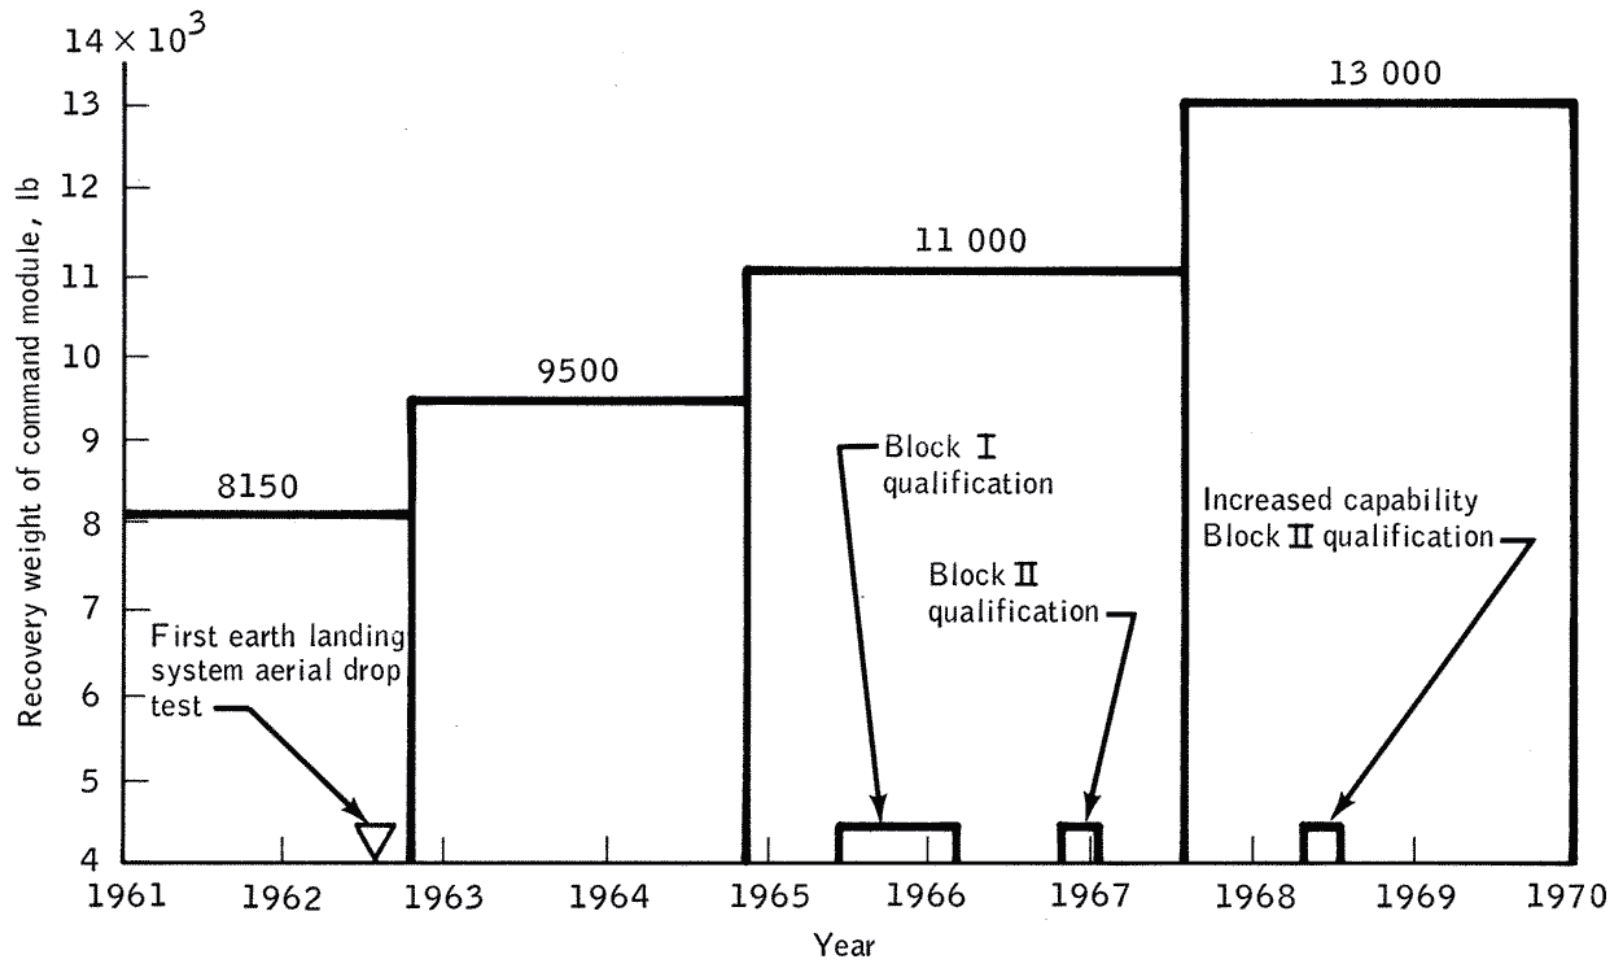
Figure 4-6.- Increases in command module recovery weight.

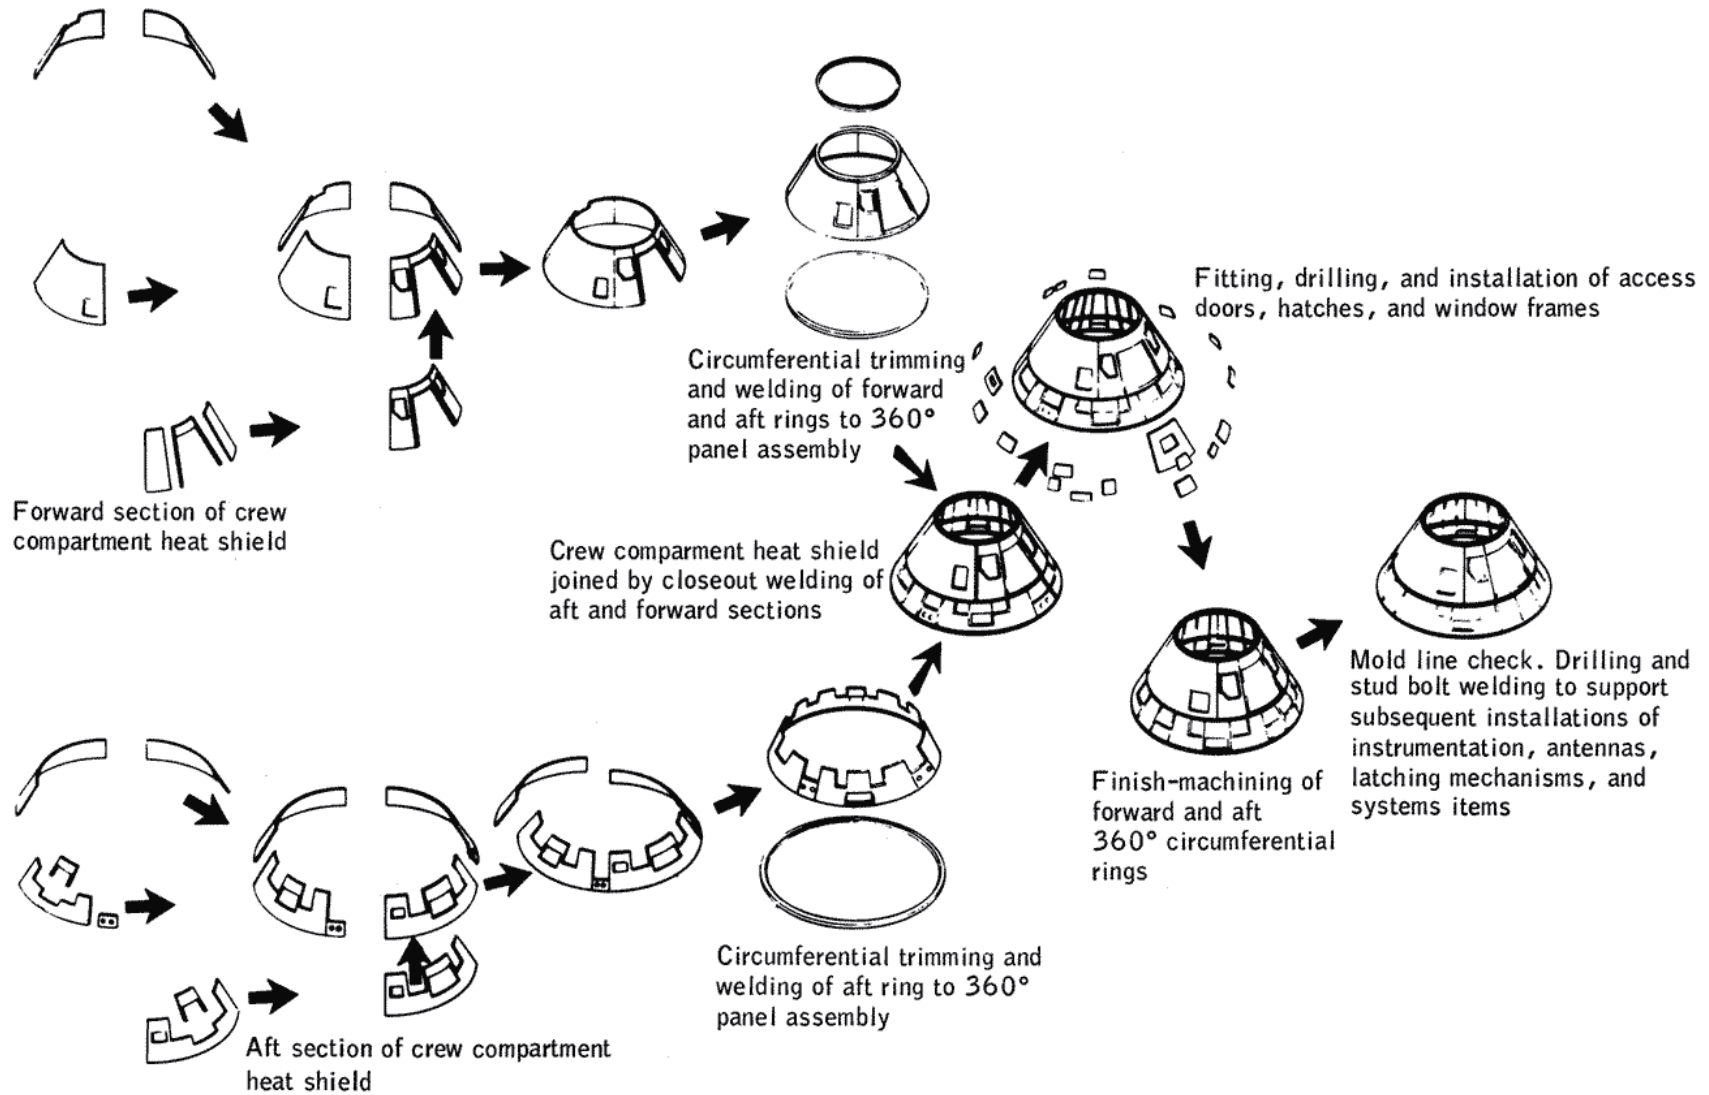
Figure 9-1.- Command module crew compartment heat shield assembly flow.
